# Lose the rails but stay on guard and safe

First it was the Royal Borough of Kensington and Chelsea, then Transport for London now other Highway Authorities are acting after the Department for Transport issued guidance examining the potential to take out pedestrian guardrailing in the UK. Malcolm Bulpitt, Andy Paul and Phil Cook of TMS Consultancy consider the latest developments.

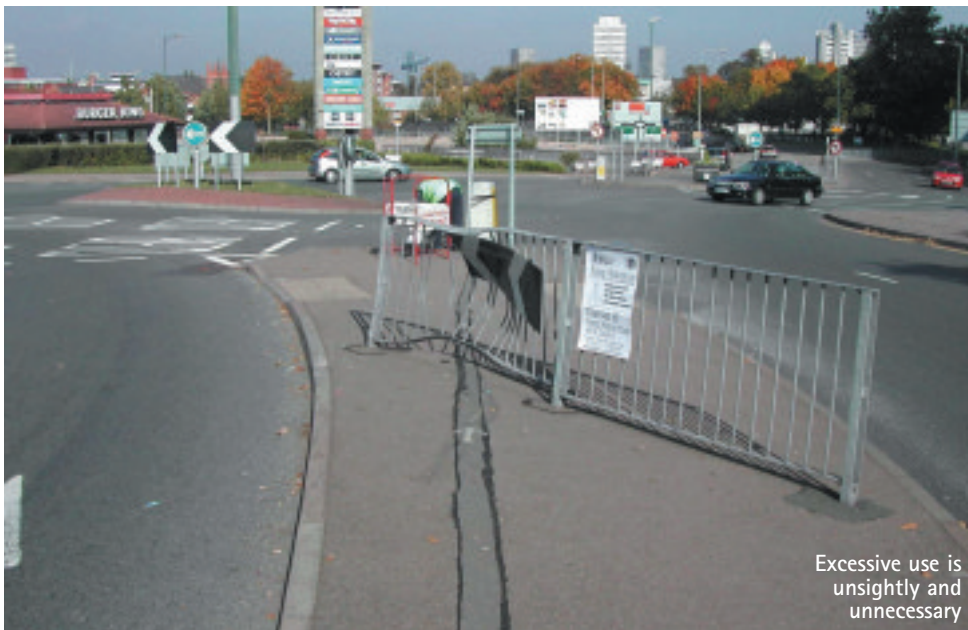
Excessive use is unsightly and unnecessary

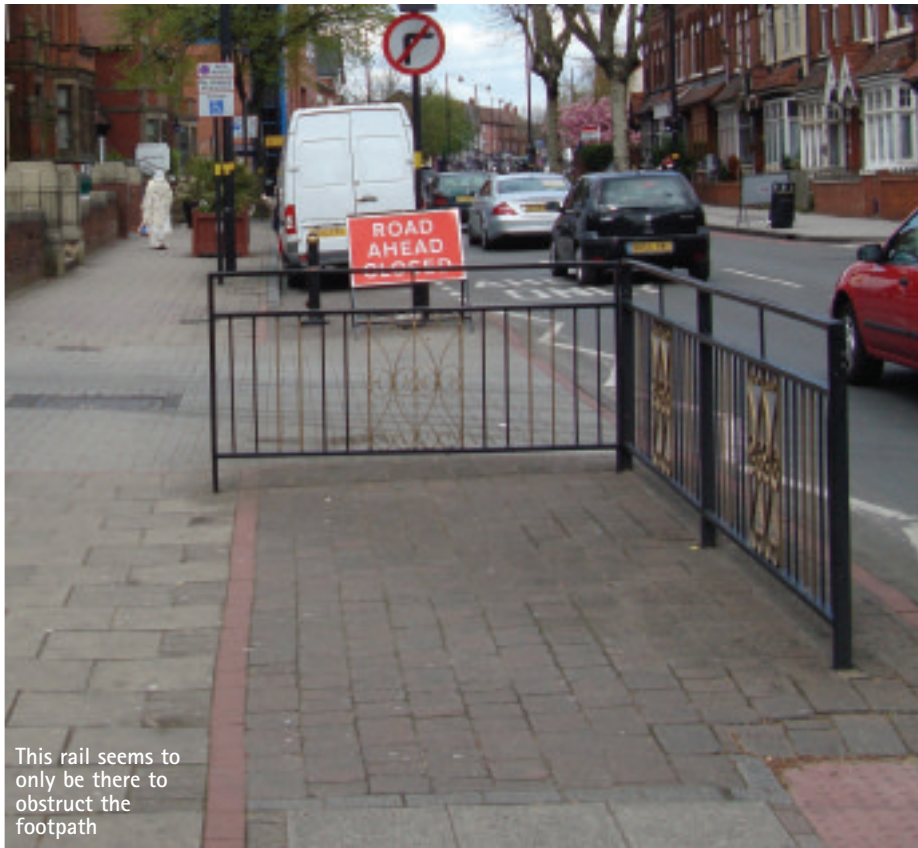
This rail seems to only be there to obstruct the footpath

The complete removal of guardrail at the type of site illustrated above should only take place following a more comprehensive assessment using the DfT/TfL guidance methodology.

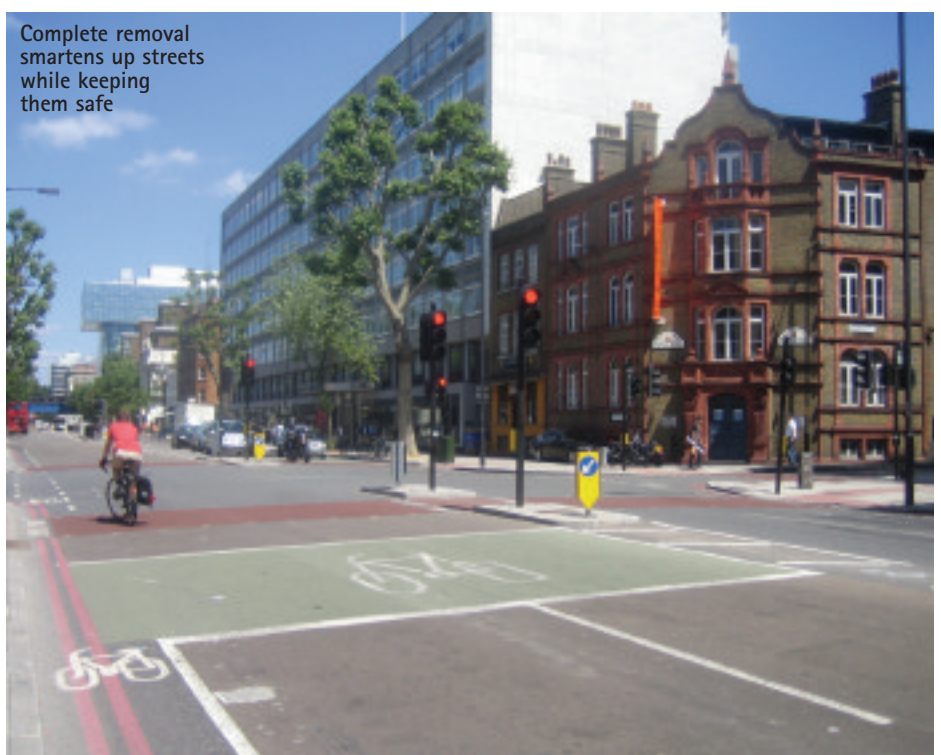
Complete removal smartens up streets while keeping them safe
